LOWER BEAVER POND DAM

CHESTERFIELD COUNTY, VIRGINIA

VA. NO. 04106

# PHASE I INSPECTION REPORT

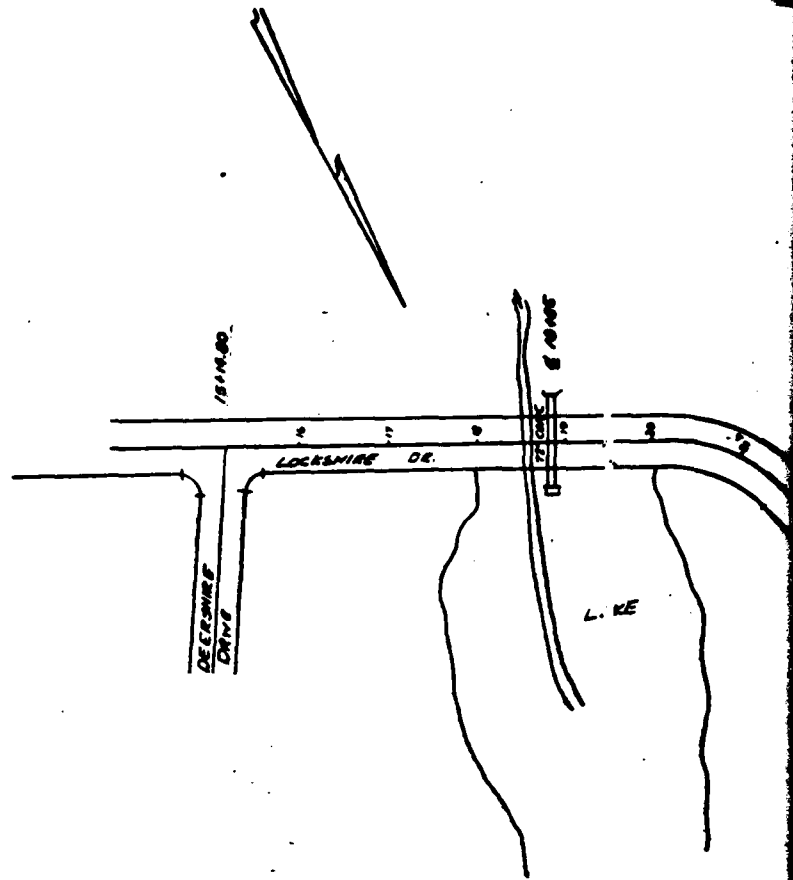
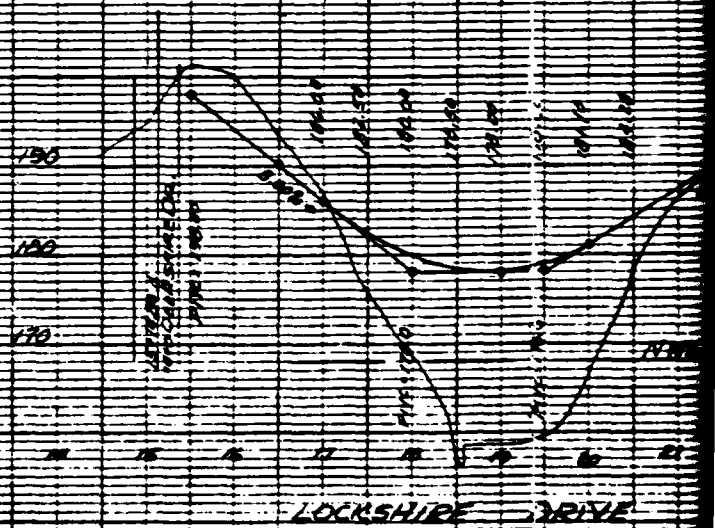
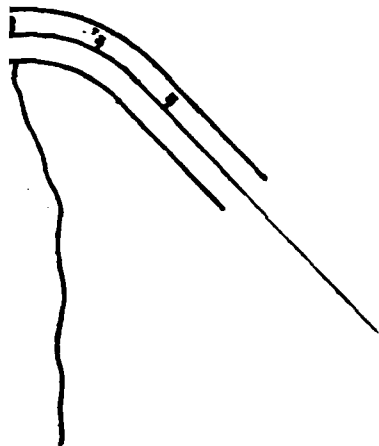
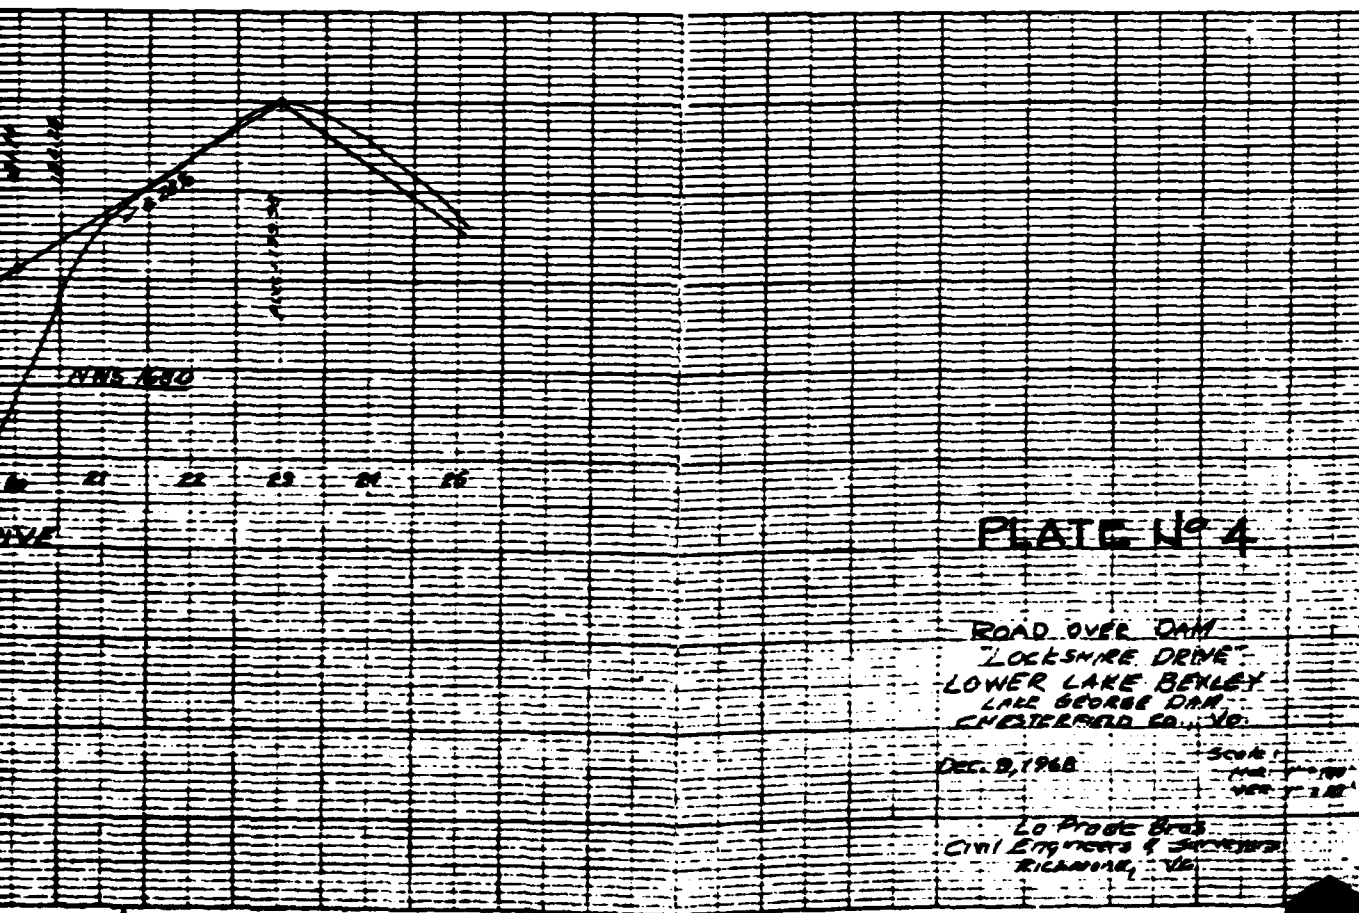
# PLATE No 4

The top of the dam was designed to conform to a roadway section and is constructed on a vertical curve (Plate No. 4, Appendix I).
